My name is Crawford Munro, BSc CEng CWEM FICE FCIWEM, a Member of the Supervising Engineer's Panel under the Reservoirs Act since 1985 and I am a current member of Yorkley & District Angling Club.

## PROVISION OF LONG TERM REPAIR AND ENHANCEMENT WORK ON LOWER CANNOP POND DAM

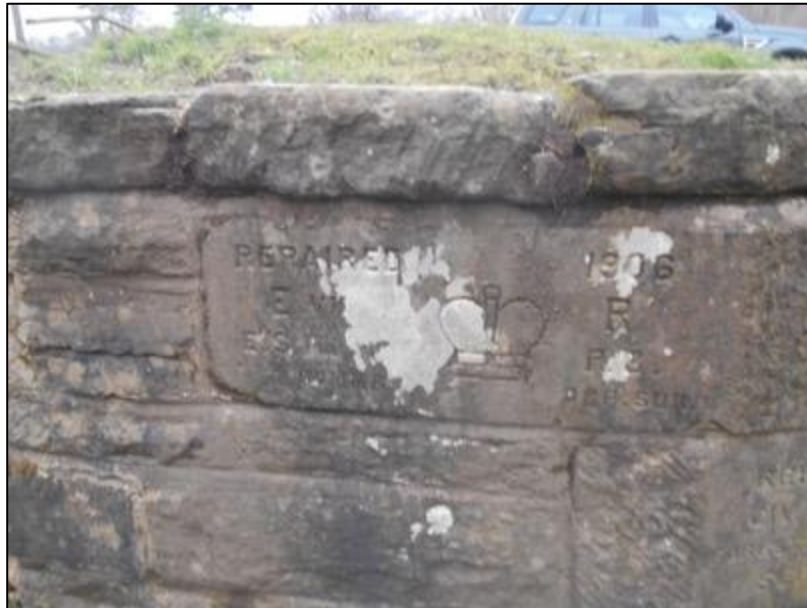
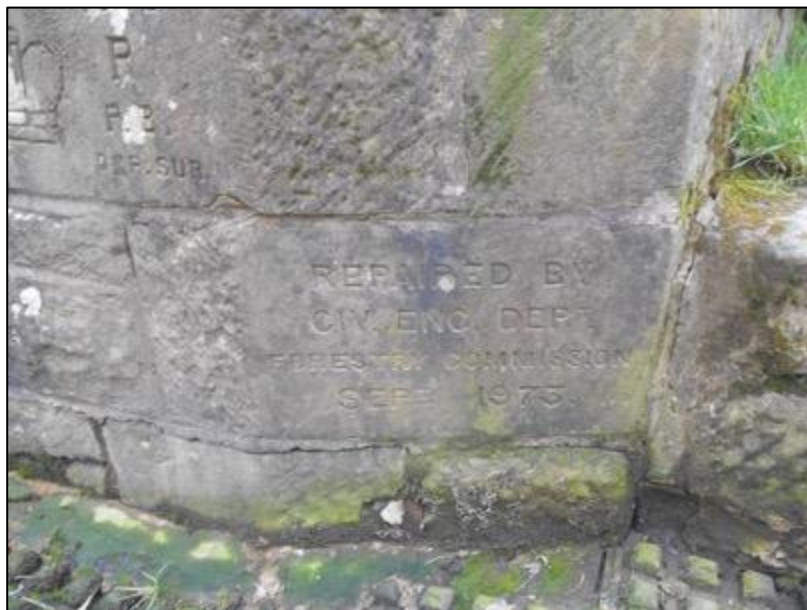
- The dam has a long history of piecemeal reactive repairs to voids within the dam embankment, including areas under the overflow weir and spillway. The following photographs bear testament to repair work in 1906 & 1973.

It appears that the repairs carried out historically have simply been to rectify damage that became apparent from time to time, rather than to address the main source of the problem! It is therefore not surprising that there have been repeated need for repairs.

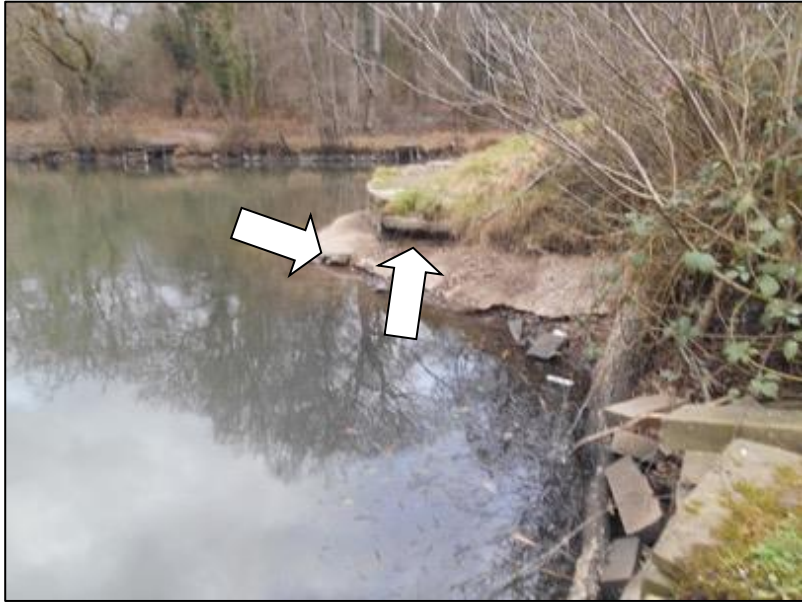
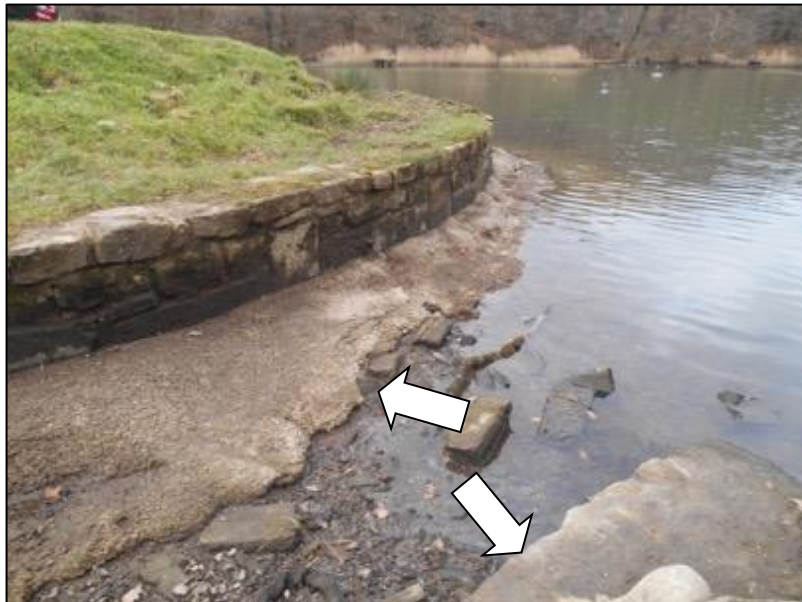
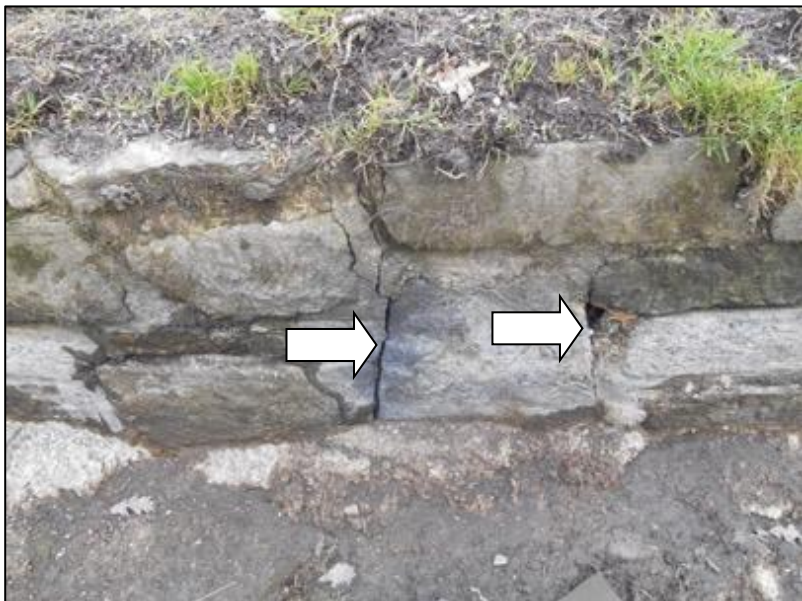
It appears that the frequency and standard of repair work has been poor, as evidenced by the following photographs, which show that in places there is scope for water to penetrate the dam with potential to cause internal erosion (in the current absence of a watertight core), leading to potential for void formation in the dam embankment from time to time (when the reservoir is returned to the overflow weir level) and the appearance of sink holes at the ground surface.

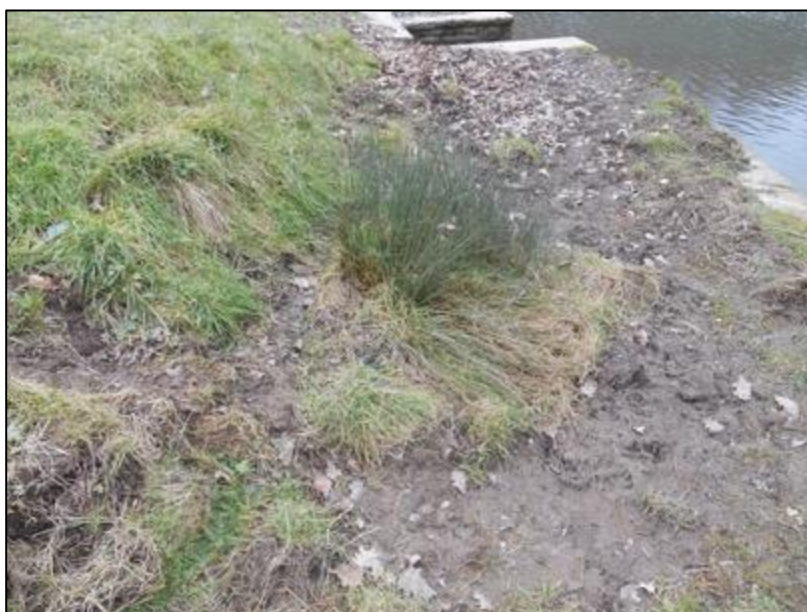
- Permanent lowering of the top water level – such as illustrated in photographs above and below, taken during my visit on 1<sup>st</sup> February 2023. The water level had been drawn down to just above the hydro-turbine intake culvert's invert. I understand that this would be acceptable to the Angling Club and probably most, if not all, who currently enjoy the pond, as it appeared not to expose unattractive muddy areas around the pond's margins.

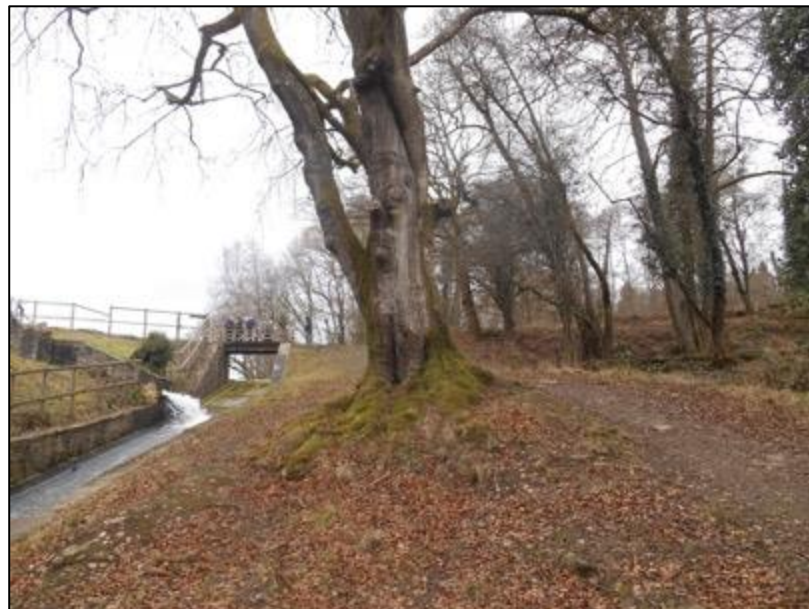
The east side of the existing spillway, would require tree felling and some regrading work to allow this as illustrated in the photograph below. It is unlikely to be viable on the west side of the spillway unless the hydro- turbine facilities are removed.

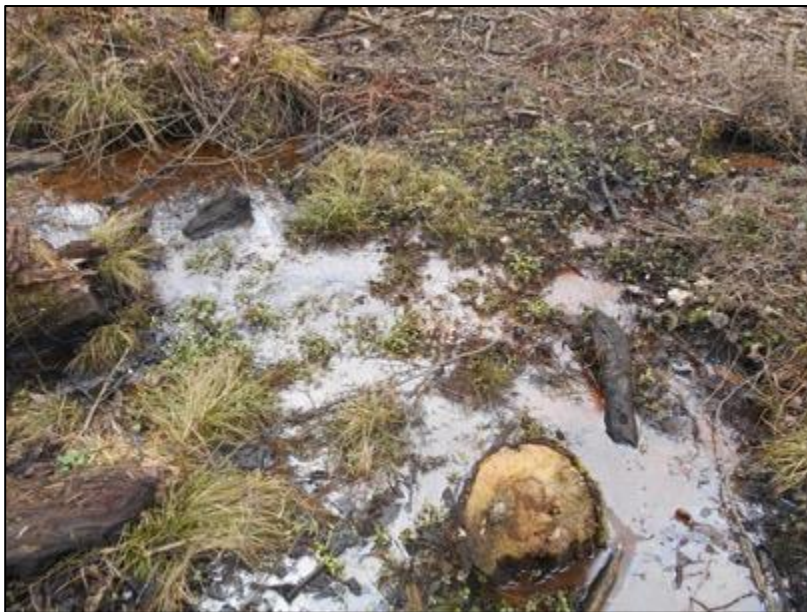
Downstream toe area – no drainage due to absence of gradient away from dam toe.

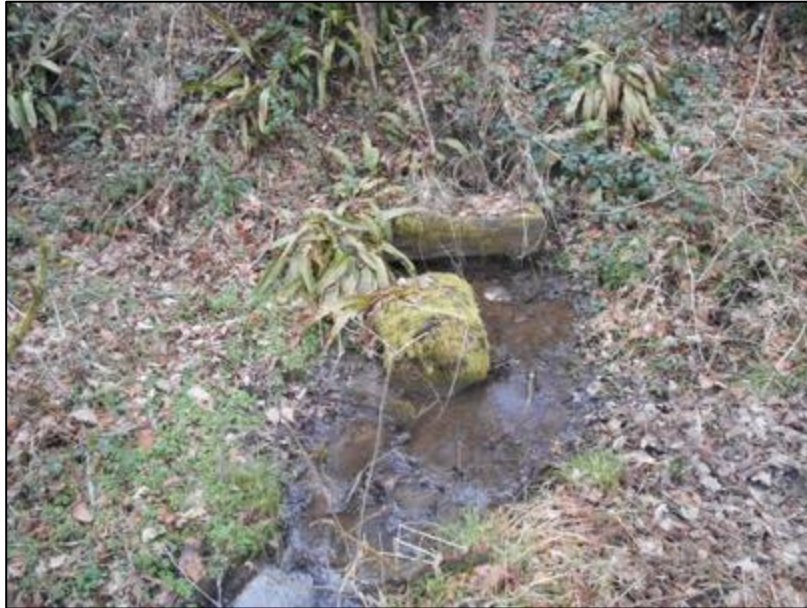
Water from road to toe area.
