My name is Crawford Munro, BSc CEng CWEM FICE FCIWEM, a Member of the Supervising Engineer's Panel under the Reservoirs Act since 1985 and I am a current member of Yorkley & District Angling Club.

## PROVISION OF LONG TERM REPAIR AND ENHANCEMENT WORK ON LOWER CANNOP POND DAM

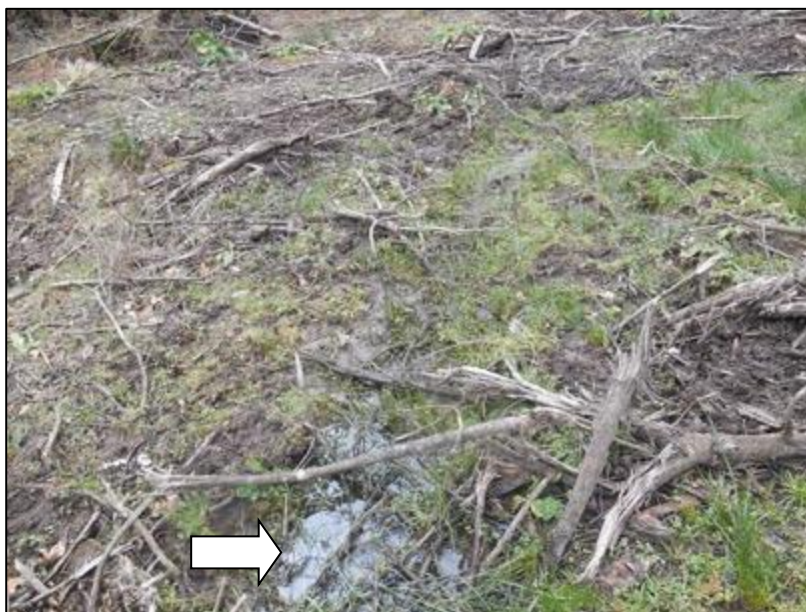
- *The dams are about 200 years old! That is not exceptional as there are hundreds of embankment dams in Great Britain of this age (and older) and they are still in service, operating satisfactorily and regularly supervised for any indications of issues arising, with remedial work undertaken before greater problems become manifest.*
- *The Lower Pond dam was built as a railway embankment and was never intended to be a water-tight structure to retain a reservoir. It is likely that there is no formal cut-off into original ground at the dam’s foundation. There is no sign of any deep-seated leakage appearing in the valley below and no evidence that this has been a problem in the past. The following photograph shows one small damp area below the downstream toe, but the cause appeared to be the lack of a drainage path from the flat area, rather than water passing through the dam.*

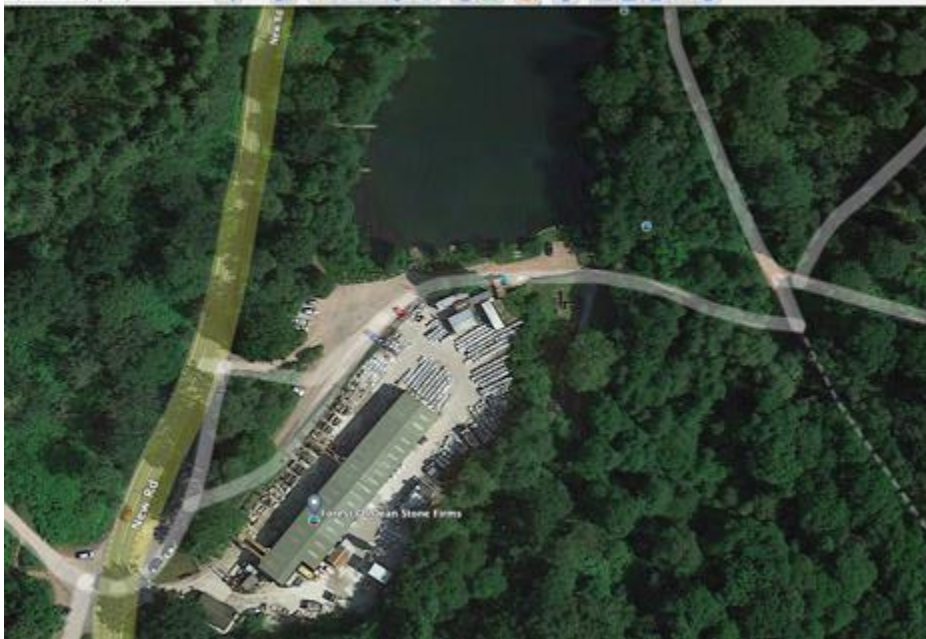
My comments are limited to Lower Cannop Pond dam meantime. A recent satellite image of the dam is shown below. There is good access to the site from the west off New Road. The Forest of Dean Stone Firms Limited's facility extends from the west to about the mid-length of the dam. The section of dam in this area is now massive and I am not aware of any seepage or settlement issues on this part of the dam embankment. Moving eastward, the dam crest is also substantial but to a lesser extent and about 10m wide
